S-A18-186

Created	2018-07-24 12:20:59 UTC by Laura Giese
Updated	2018-09-06 14:06:17 UTC by Joseph Roy
Location	36.8232403, -79.3525951
Status	■ Finalized & Approved
Client	NextEra
Project	MVP Southgate
Date	18/07/24
Date2	180724

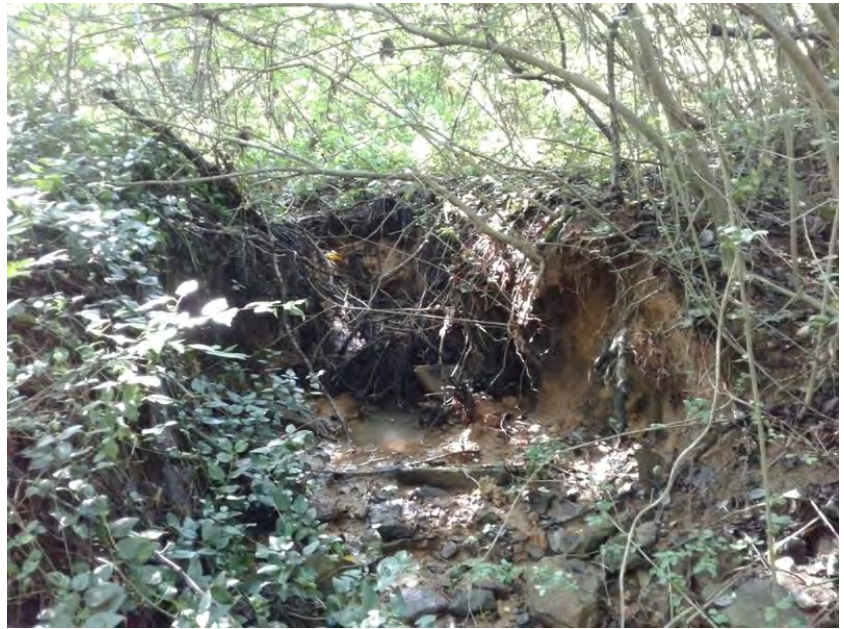
Headcut by flag 9 and 108

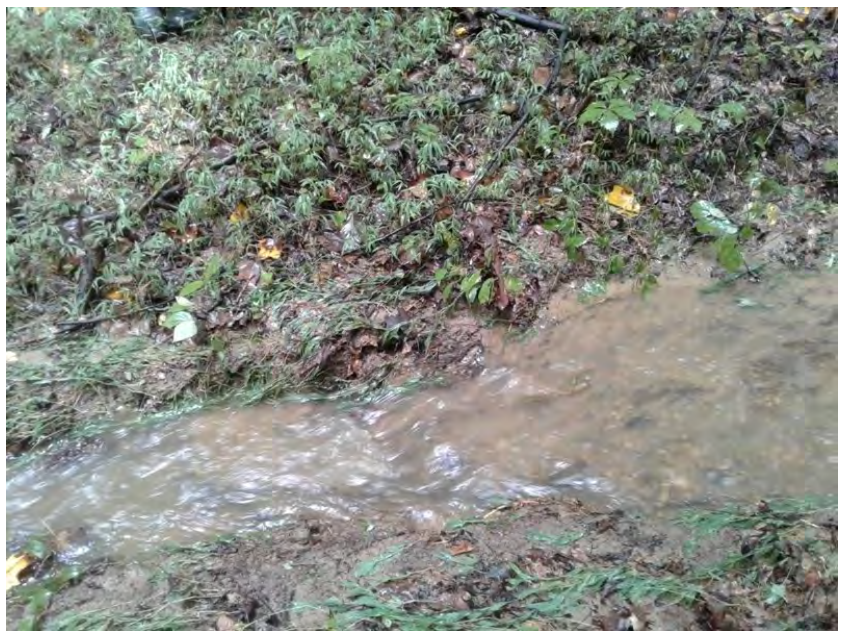
Across Stream Photo 1

Confluence

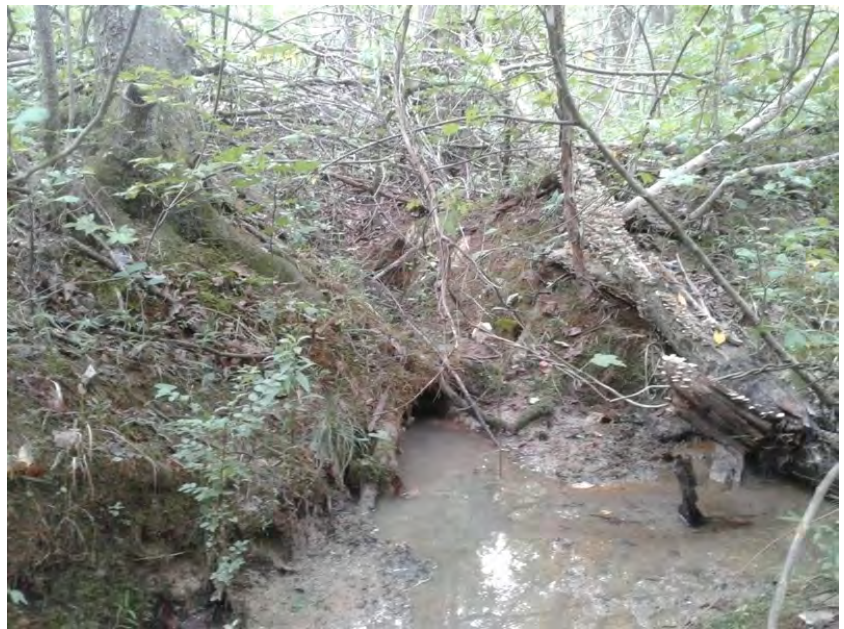
upstream of 101 flag
