S-A18-186

Created	2018-07-24 12:20:59 UTC by Laura Giese
Updated	2018-09-06 14:06:17 UTC by Joseph Roy
Location	36.8232403, -79.3525951
Status	■ Finalized & Approved
Client	NextEra
Project	MVP Southgate
Date	18/07/24
Date2	180724

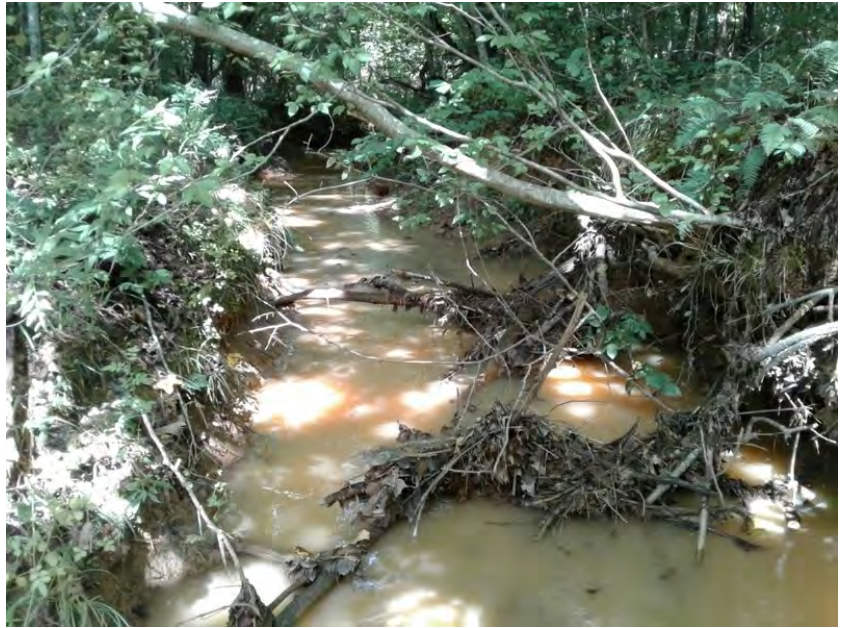
upstream of ROW UP

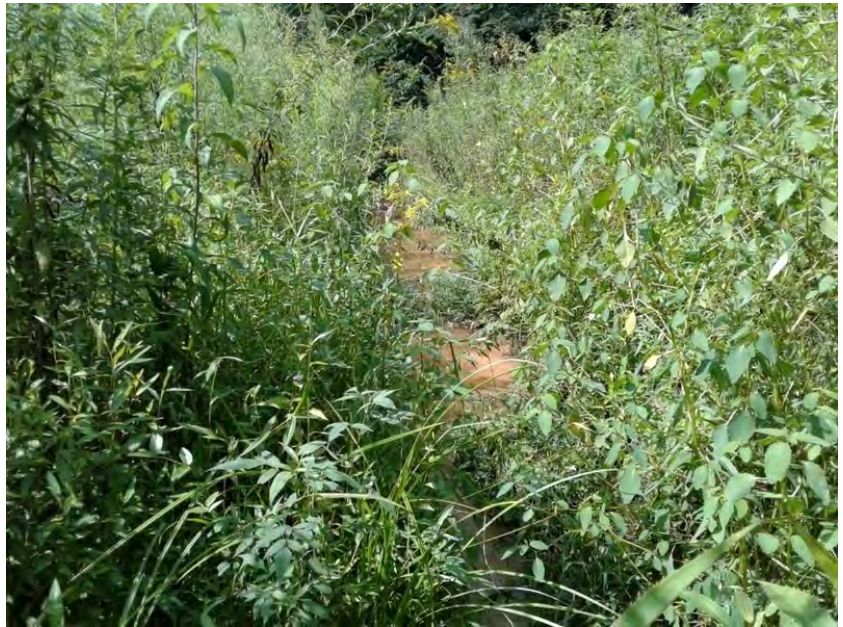
in ROW UP

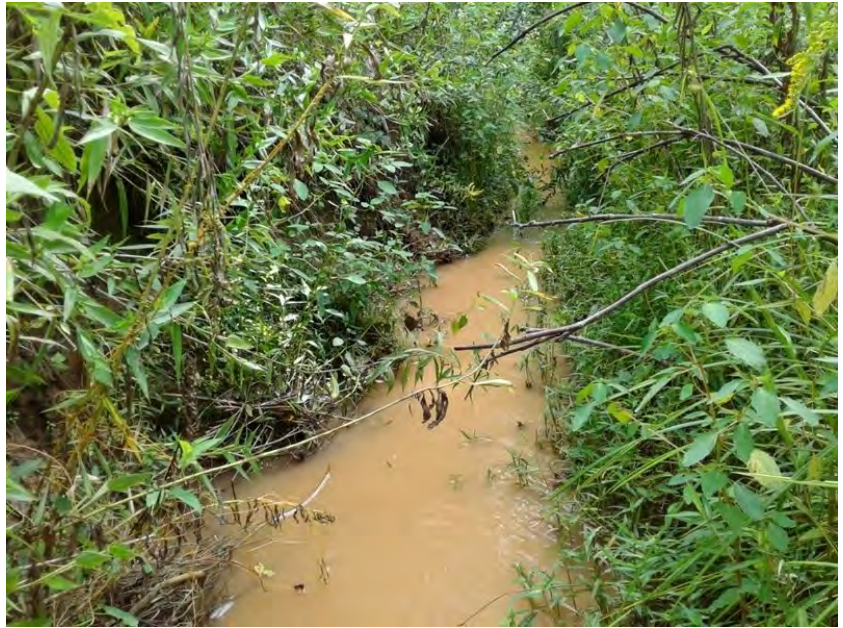
in ROW DN
